# White House, Bathroom

## Description

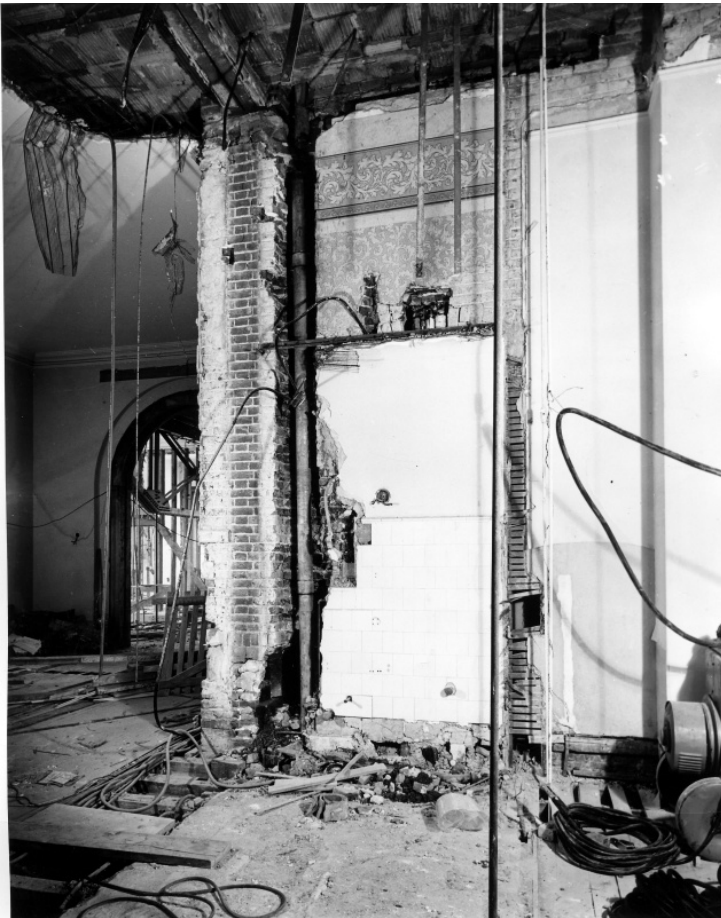
Southwest view from Bathroom B-14, taken during the renovation of the White House. The brick wall, one of the main support columns of the White House, was weakened by cutting into the bricks for installation of a water pipe many years ago.
