Pouring concrete at the White House

January 13, 1950

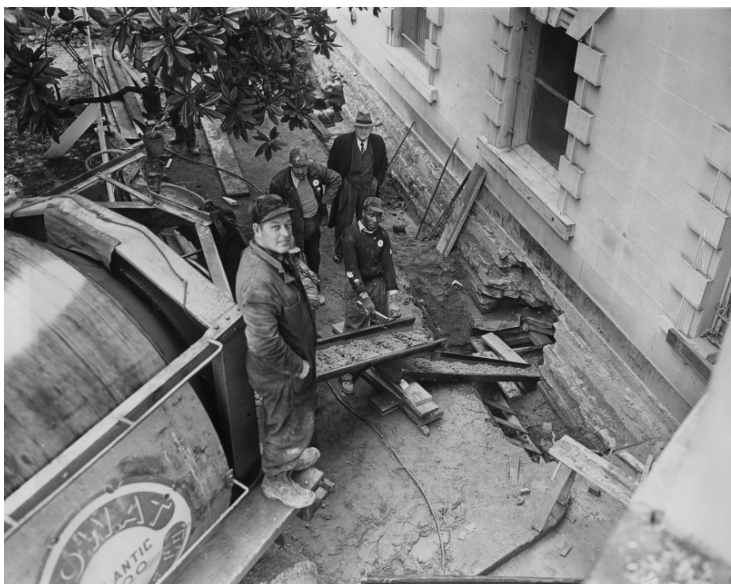
Accession Number 58-531-013

Concrete being poured in the first excavation for underpinning on the south side of the White House outside Room G-12. The excavations are carried down to gravel about 27-30 feet below grade and are boxed in as work progresses.
