# Southeast View of Yellow Bathroom in the White House

February 23, 1950

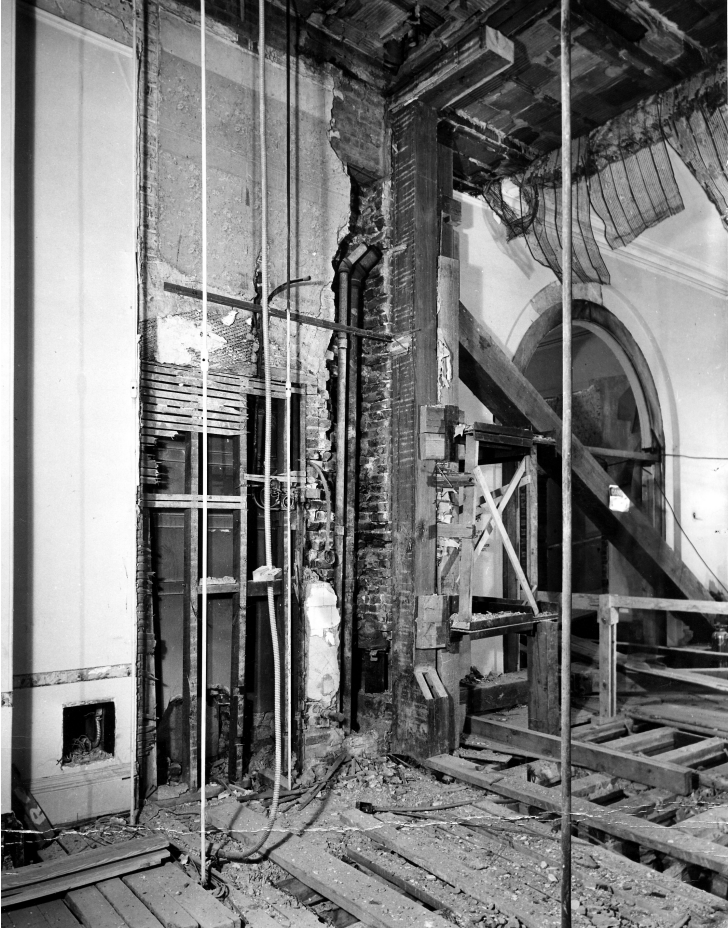
Southeast view of the Yellow Bathroom (B-13), into corridor and brick wall west of the stairway, which is one of the main support columns of the building. The wall has been weakened greatly by cutting into the bricks for the installation of the water pipes shown in the photograph. From a series of photographs of the renovation of the White House.
