# View from Servant's Dining Room at the White House

February 6, 1950

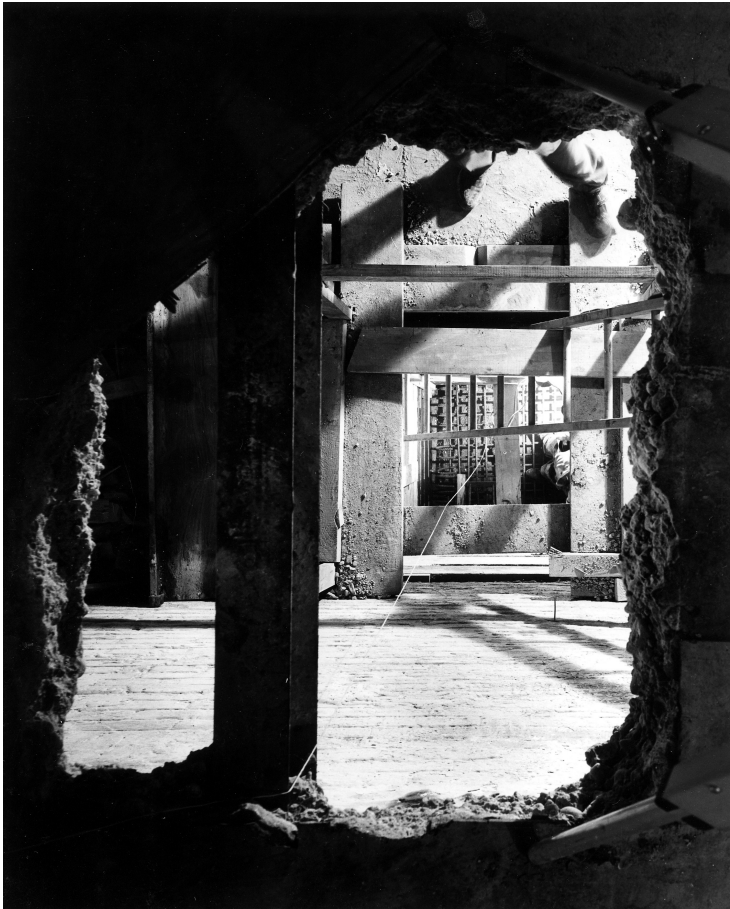
A view from the Servant's Dining Room to the bottom of an underpinning pit approximately 30 feet below. The concrete underpinning here will support a steel girder reaching to the roof of the White House. This is from a series of photographs of the renovation of the White House.
