# Southwest view from Main Corridor during renovation of White House

## Description

March 17, 1950

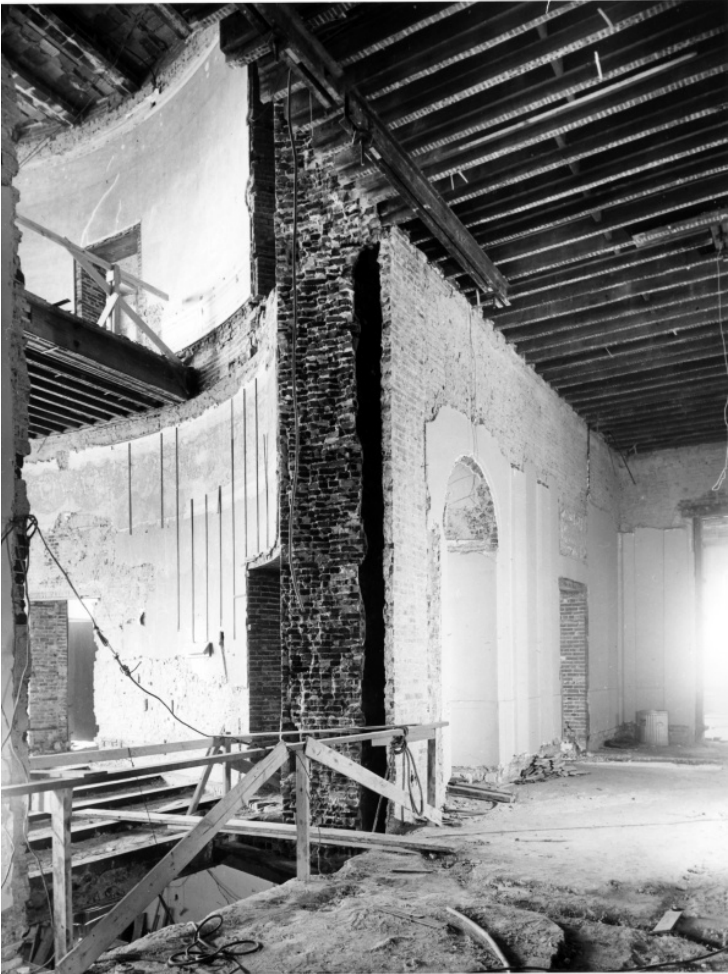
Southwest view from Main Corridor into entrance of the Blue Room during renovation of the White House. The archways and the brick walls on each side of the entrances to the Blue Room and Study (above) were taken down for installation of steel shoring columns. Between the Blue Room and Green Room on the north, the walls contained large openings as shown in the photograph.
