Photograph under center pier in the Broadcasting Room during White House renovation

May 2, 1950

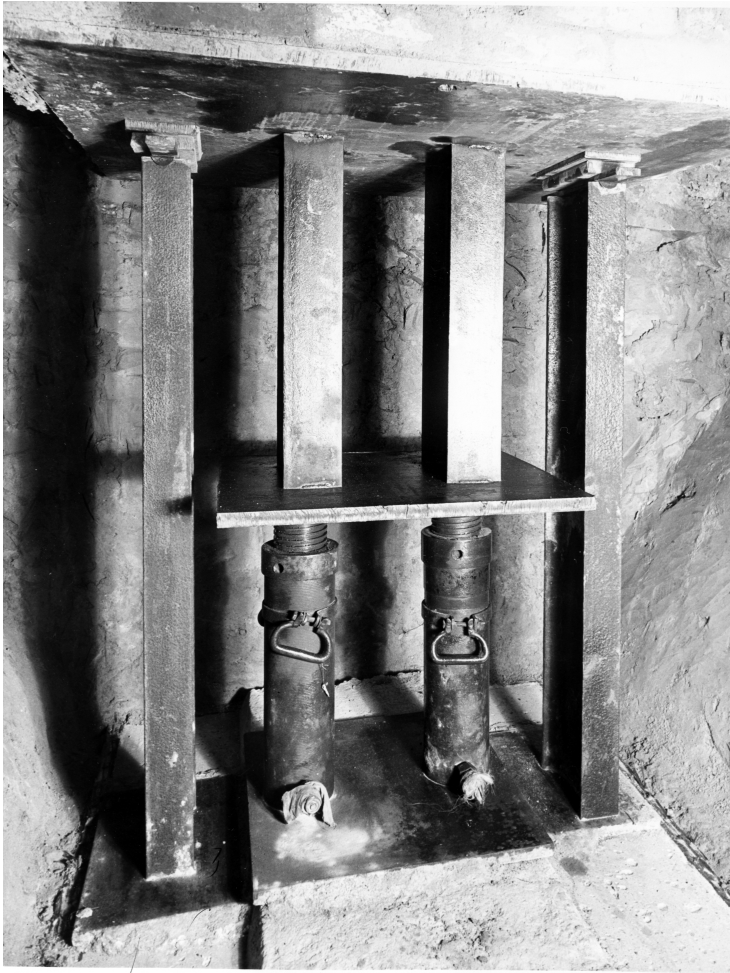
Photograph under center pier in the Broadcasting Room, 4 feet below old foundation, during the renovation of the White House. The steel wedging beams were installed to test amount of weight on foundation. The jacks were raised so that building above moved 1 millimeter, instruments recorded a pressure of 76 tons.
