Joists at Northeast Corner of the Red Room

April 14, 1950

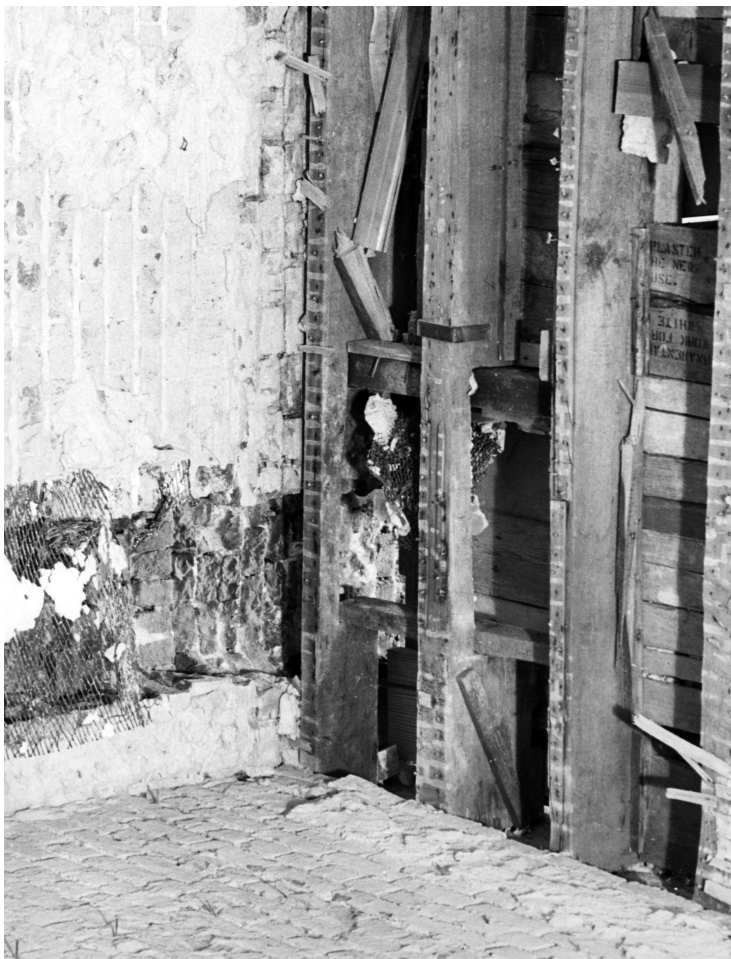
These joists at the northeast corner of the Red Room were uncovered during the renovation of the White House. The joists were cut into and weakened apparently to provide space for the pipes to the bathroom of Room 20 above.
