## Openings in the north wall during renovation of the White House

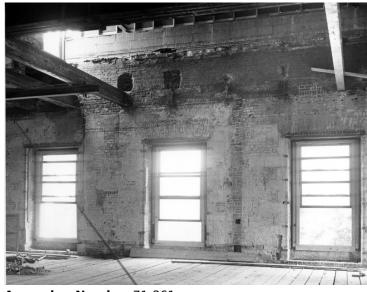
**Accession Number** 71-361

Openings in the north wall near the northeast corner of the White House for tying in large horizontal beams to be installed along the wall. The beams are to be placed above Rooms 23 and 24.
