# View from center hall to southeast corner of the White House during renovation

November 10, 1950

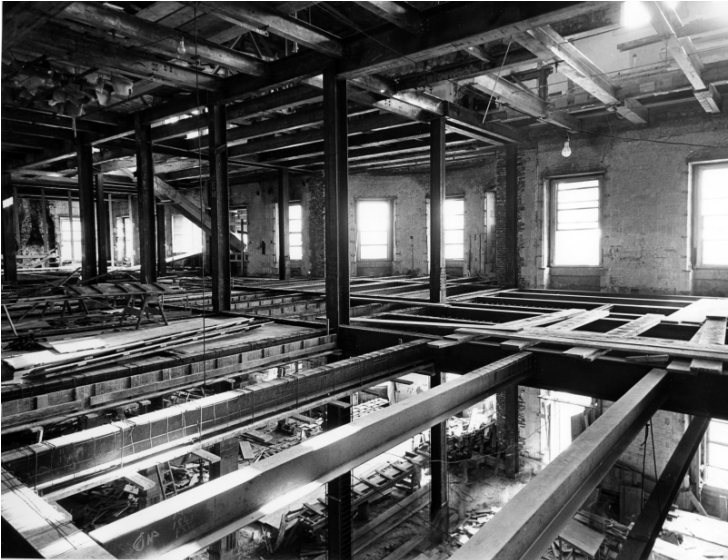
View from center hall to southeast corner of the White House during renovation. The oval study is at the center. Wire reinforcement and wooden forms are being installed for pouring the concrete floor already completed in the eastern part of the second floor.
