Southeast view in the State Dining Room of White House during renovation

January 11, 1952

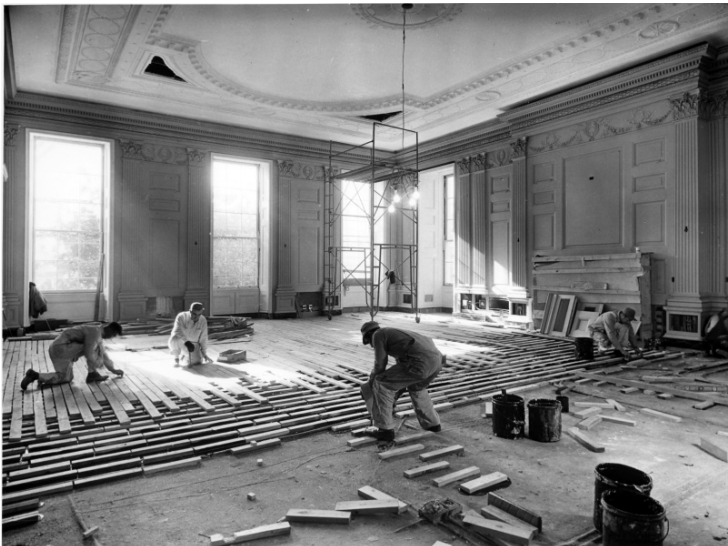
Southeast view in the State Dining Room of the White House during renovation. Wooden blocks are set in tar and sub-flooring nailed to them, running in the opposite direction.
