Oil slick from break in pipeline

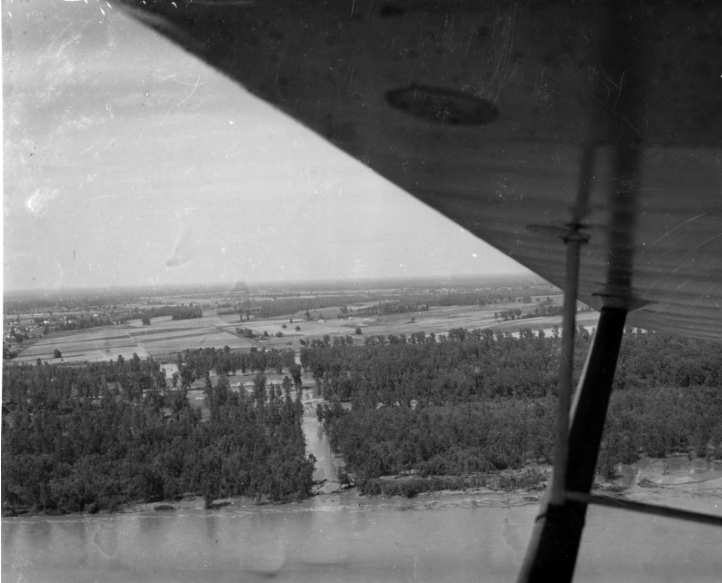
Oil slick caused by crude oil trapped between emergency gate valves, shut when flood damage occurred in "Big Inch" river crossing, seeped to the surface along bank of Arkansas River to mark the point of break in 24 inch War Emergency Pipeline. Raging water gouged back hundred of feet of river bank and caused the "Big Inch" to break far north of the river channel.
